Inspection Report

Permit Number:	C0150007		
Inspection Type:	PARTIAL		
Inspection Date:	Thursday, June 30, 2005		
Start Date/Time:	6/30/2005 2:00:00 PM		
End Date/Time:	6/30/2005 5:00:00 PM		
Last Inspection:	Tuesday, May 31, 2005

Site: **HIDDEN VALLEY MINE**

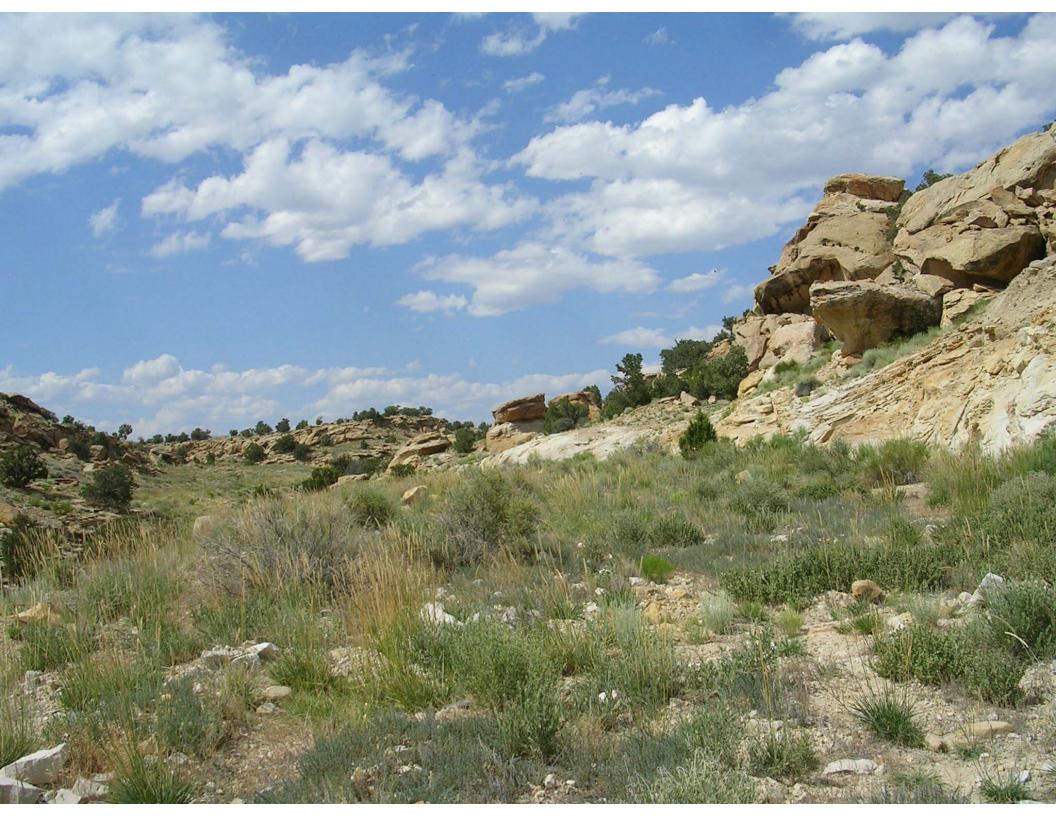
Clearing the rocks and making other repairs (as noted below) will require a track hoe to pass over the access road only twice (entry and exit). A photo was taken of the road looking north from the stream crossing to establish current conditions. The site is very dry and lasting effects to the vegetation is not expected.
